Manhole Inspection Summary

Manhole # S11II1018MH

Location Address: **REAR 4418 REISTERSTOWN RD** Cross Street: **TOWANDA AVE**

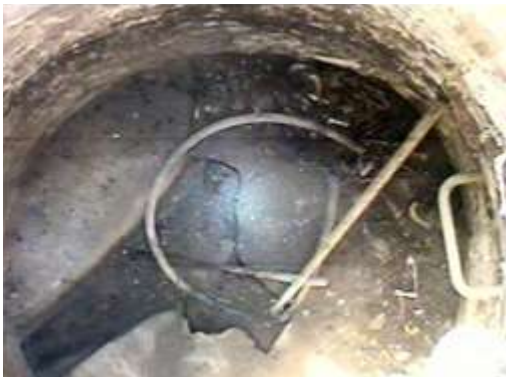
Defect 1

Condition: ☐ Sound ☐ Cracked ☐ Root Intrusion ☐ Deteriorated ☐ Leaks ☒ **Debris**

DEBRIS IN THE CHANNEL

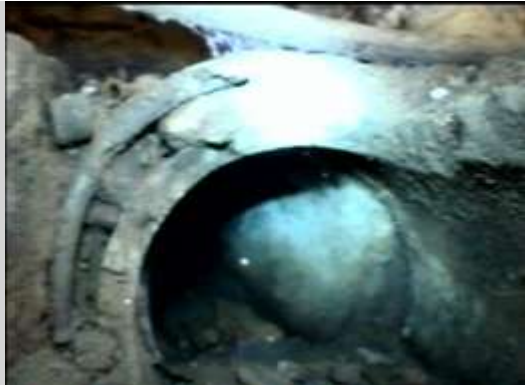
12 O'Clock Outflow

6 in. Circular Gravity Sewer
Pipe Out @ 12 O'Clock

Deposits: ☐ None ☐ Mud ☐ Sludge ☒ **Debris** ☐ Grease

Silt Depth: **0.25** (in.) Deposits Extent: **Light**

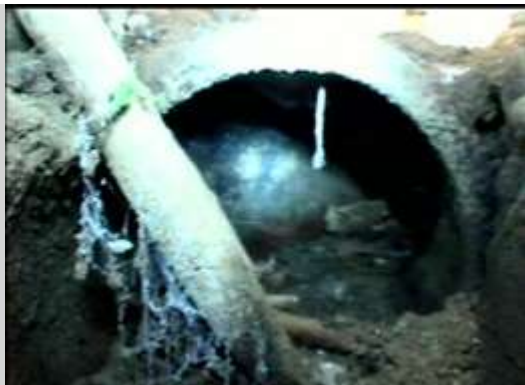
5 O'Clock Inflow

6 in. Circular Gravity Sewer
Pipe In @ 5 O'Clock

Deposits: ☐ None ☐ Mud ☐ Sludge ☒ **Debris** ☐ Grease

Silt Depth: **3** (in.) Deposits Extent: **Medium**

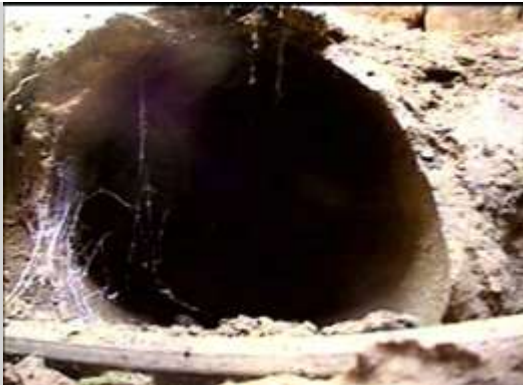
6 O'Clock Inflow

6 in. Circular Gravity Sewer

Pipe In @ 6 O'Clock

Connects To: **Stub connection / abandoned**

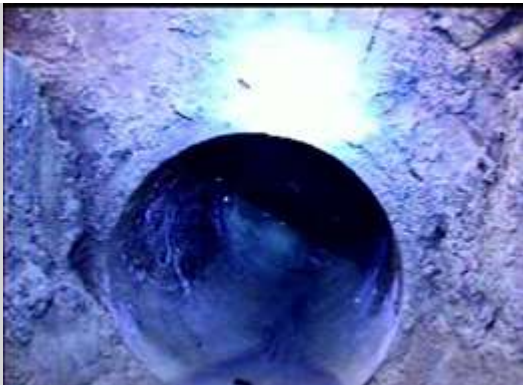
7 O'Clock Inflow

8 in. Circular Gravity Sewer

Pipe In @ 7 O'Clock
